TUNNEL IDENTIFICATION AND DESCRIPTION

INSPECTION TEAM: T. Suthers, J. Wolfe (Burgess & Niple, Inc.)

FIELD INSPECTION REPORT**STRUCTURE NO. 8-8****INSPECTION DATE: 12/13/05**

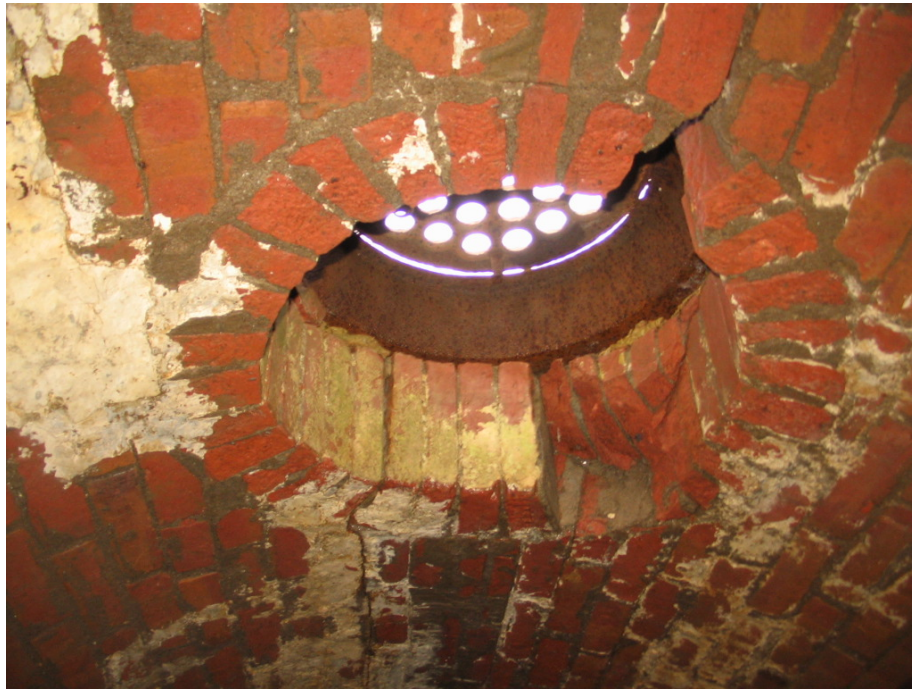
Photo 5: Chipped bricks on ceiling around vent hole

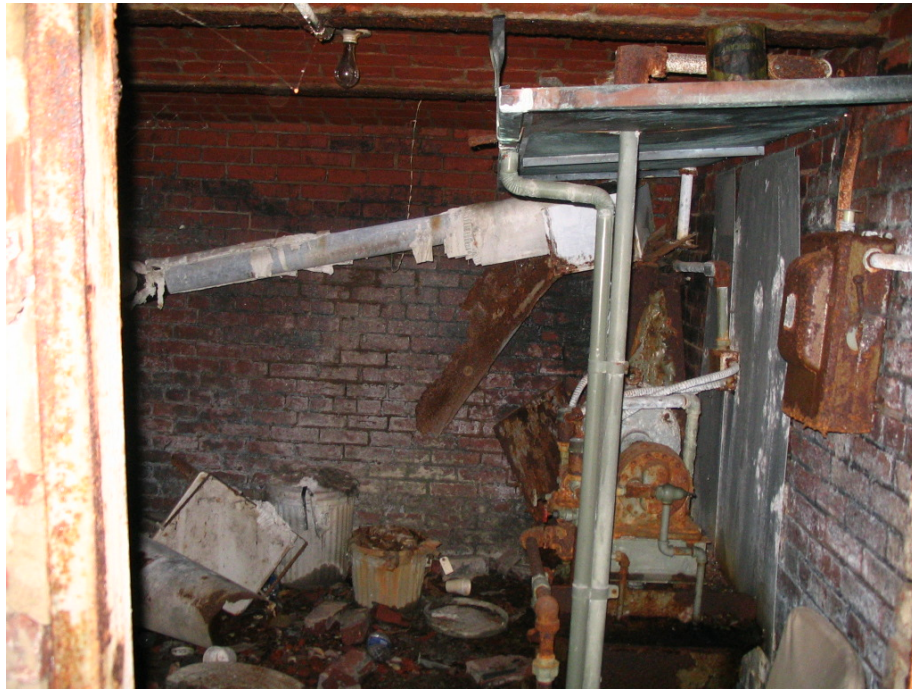
Photo 7: General view of storage room across from elevator to Building 34, west side

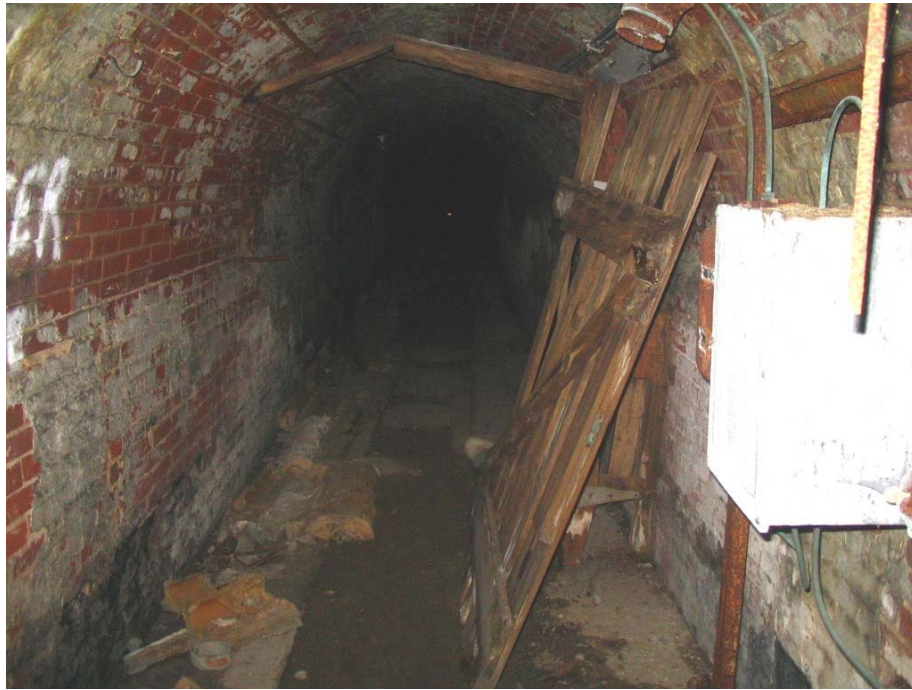
Photo 9: Damaged timber gate, 20' south of north portal

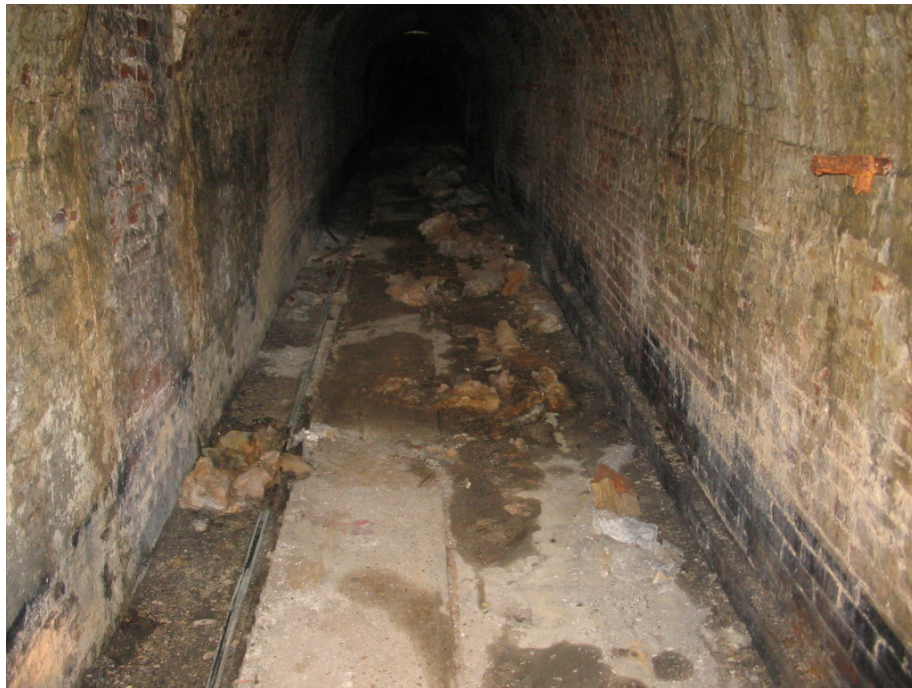
Photo 10: Typical debris on floor, looking north from Building 34

1. Remove debris from floor, 20 CY.
2. Replace electric lines, 640 LF.
3. Replace lighting conduits and wiring, 640 LF.
4. Repair water leak through lining near south end, Lump Sum.

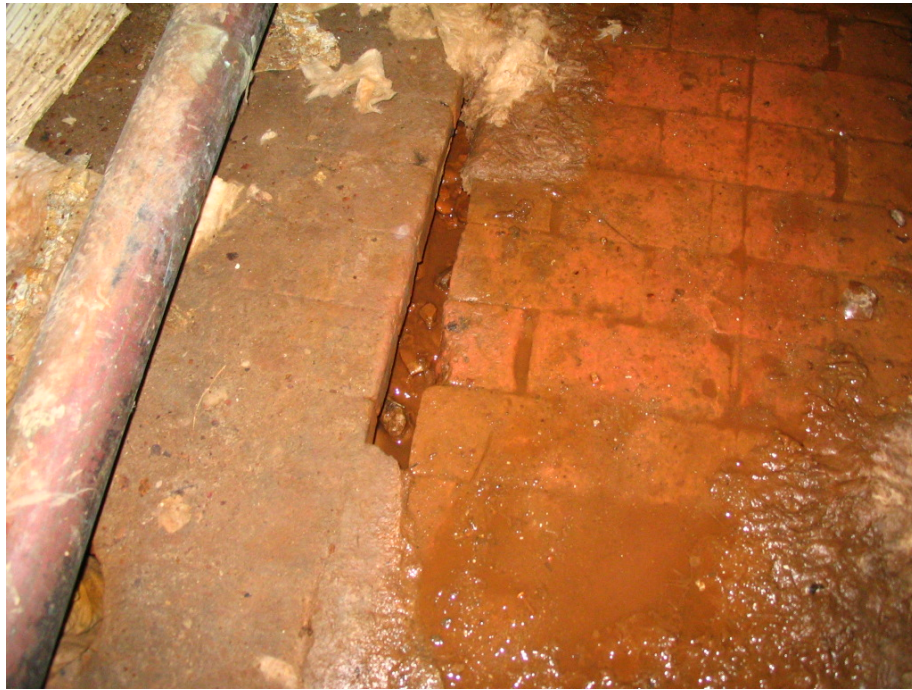
Photo 11: Water running and draining along floor near south end

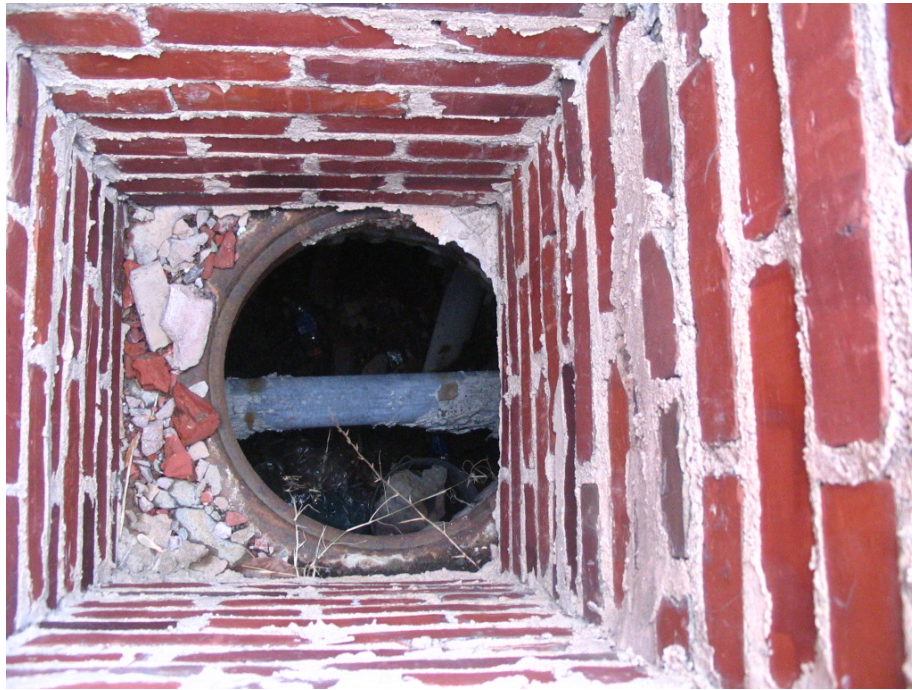
Photo 13: Vent to tunnel near Building 34

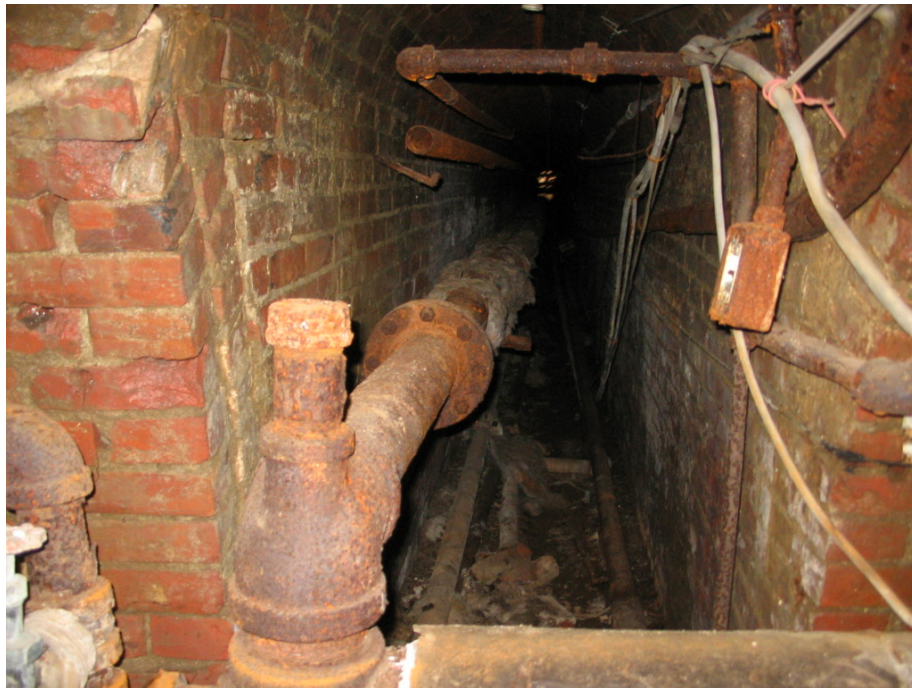
Photo 14: Utility tunnel from east wall near Building 34 to Building 36;
Note corrosion on steam and water lines

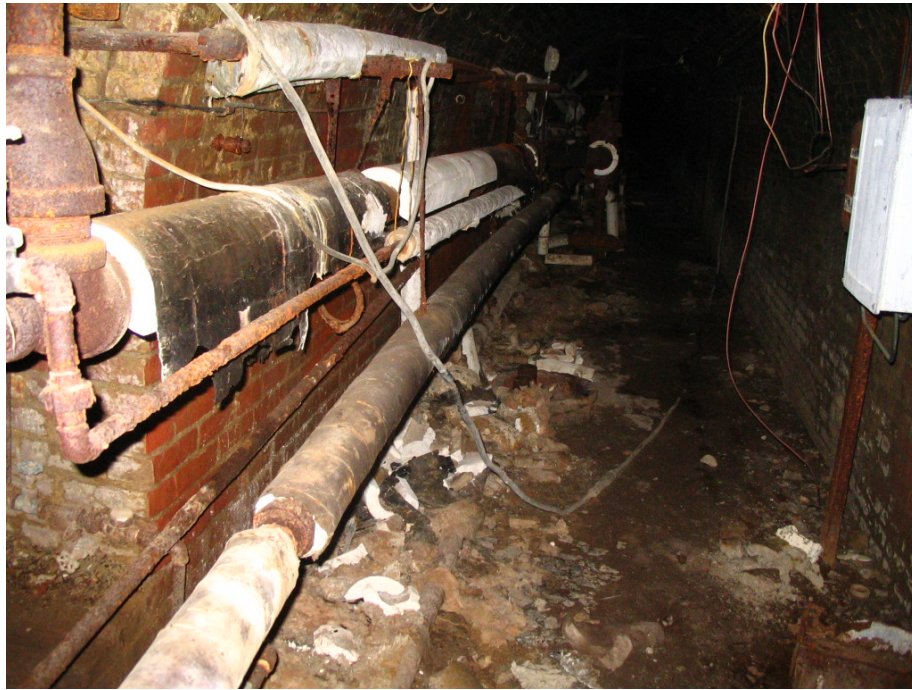
Photo 15: Rusty utility pipes and downed electric lines adjacent to tunnel to Building 36; Note debris on floor

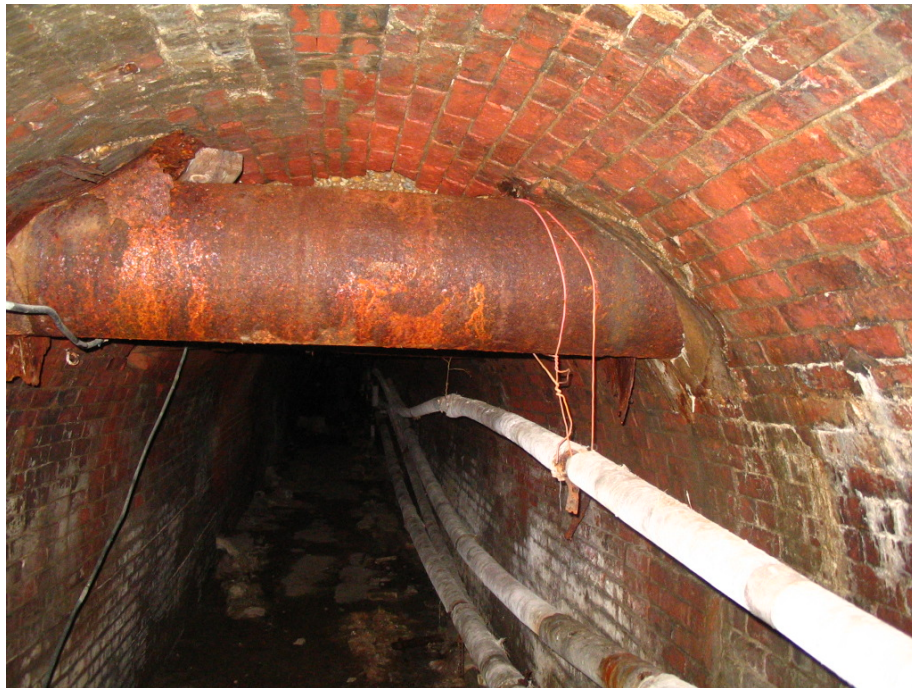
Photo 16: Water pipe hanging by wire from rusted pipe; Note sag in water pipe

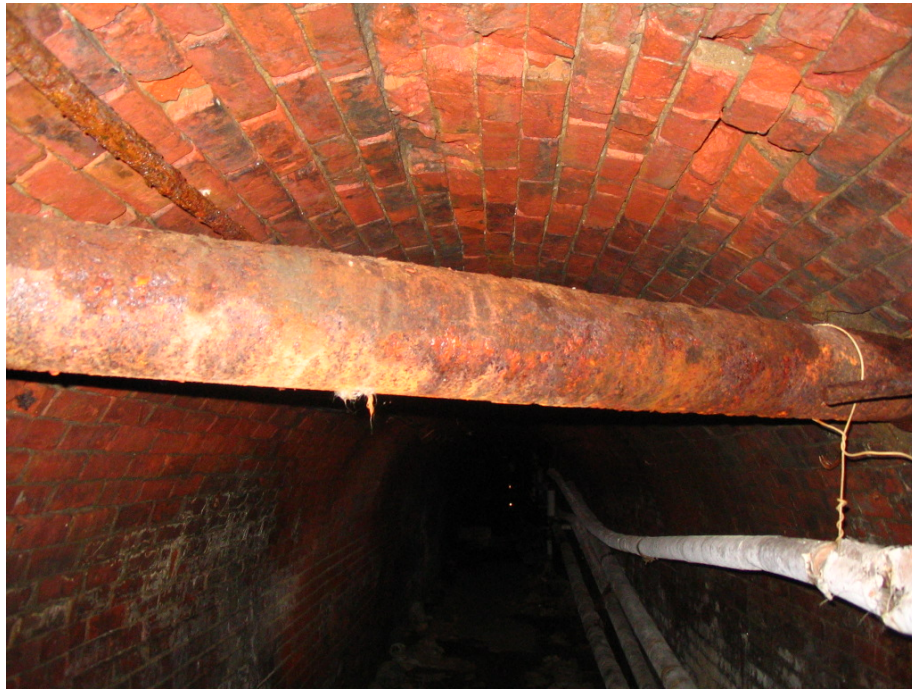
Photo 17: Moderate rust on pipe; Note water line suspended by wire

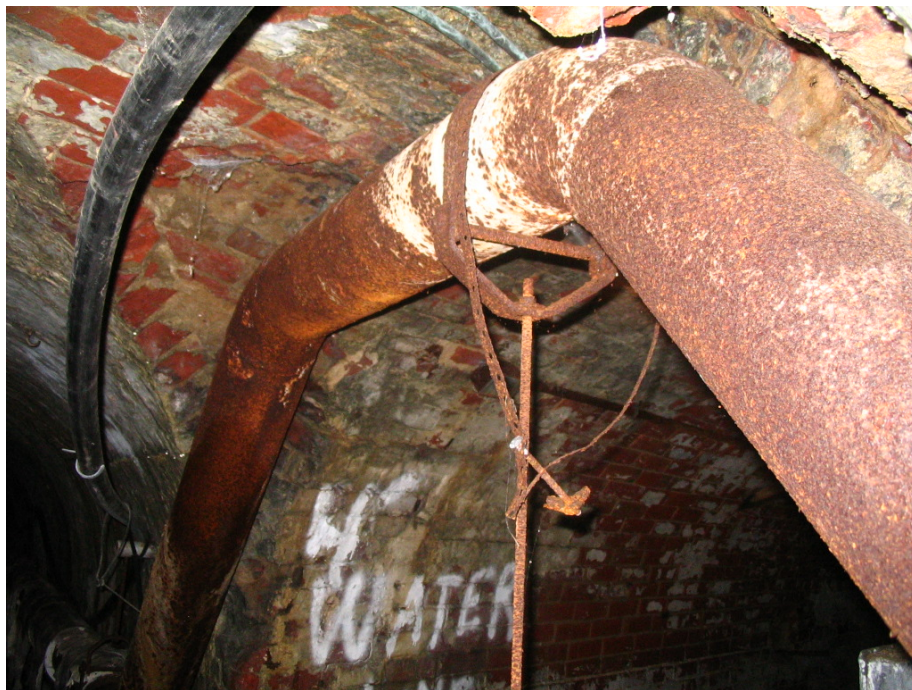
Photo 18: Steam pipe over north portal

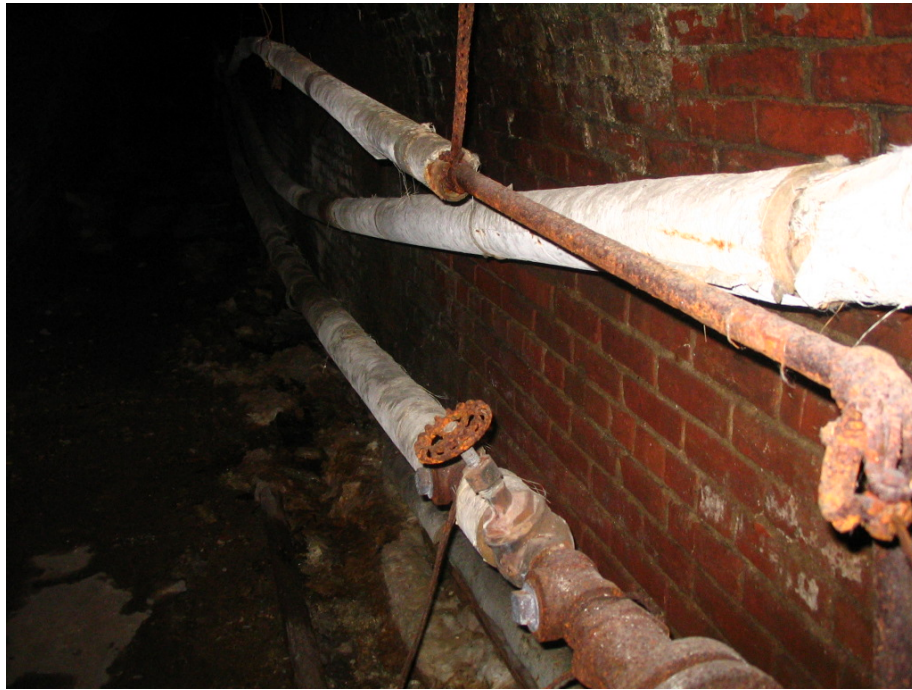
Photo 19: General view of rusted valves and piping, north of tunnel to Building 36

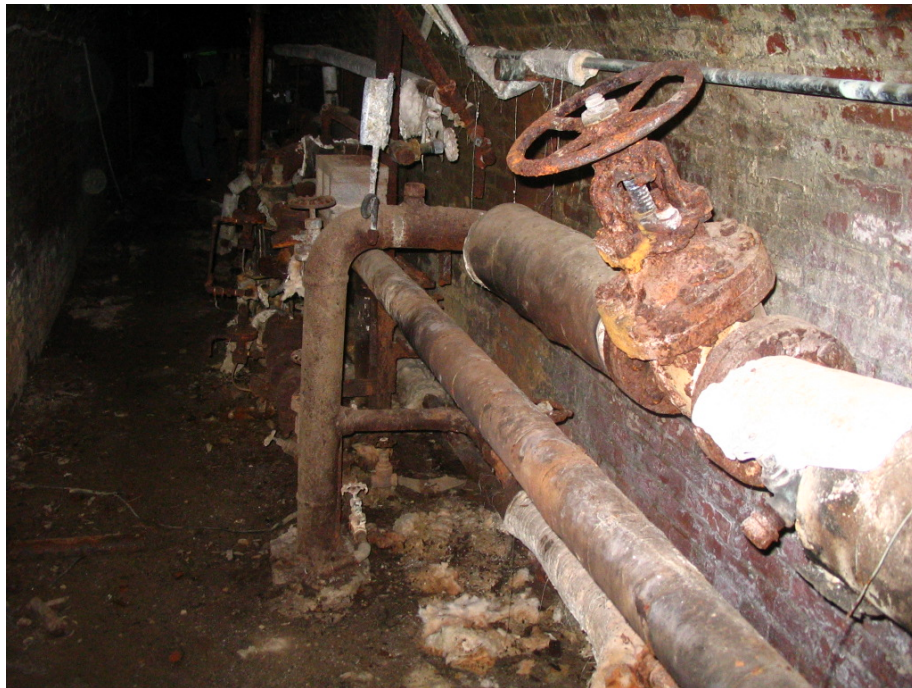
Photo 20: Rusted valve and piping at Building 38

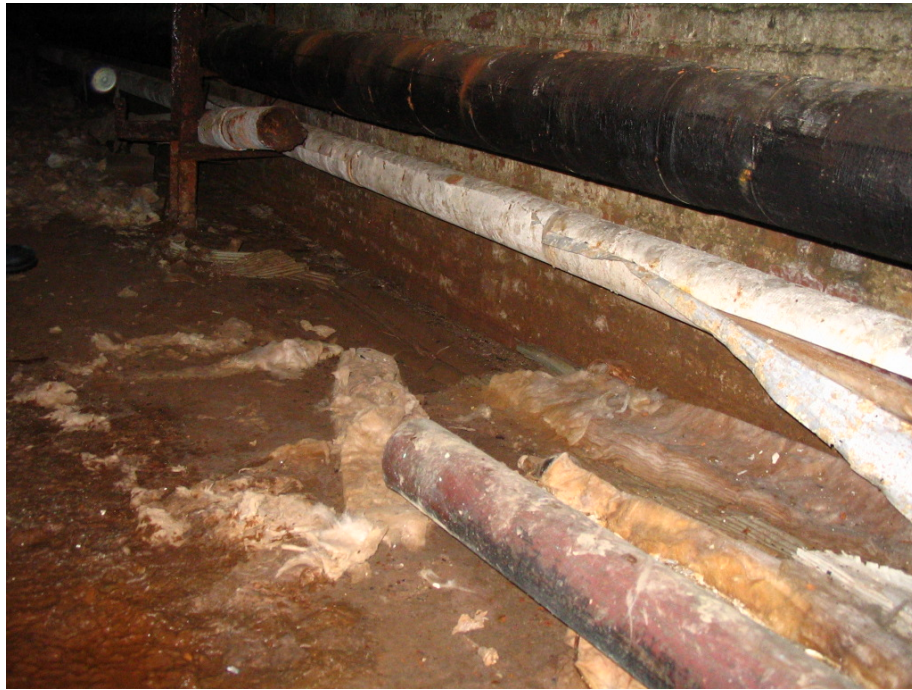
Photo 21: Disconnected 4" diameter copper pipe

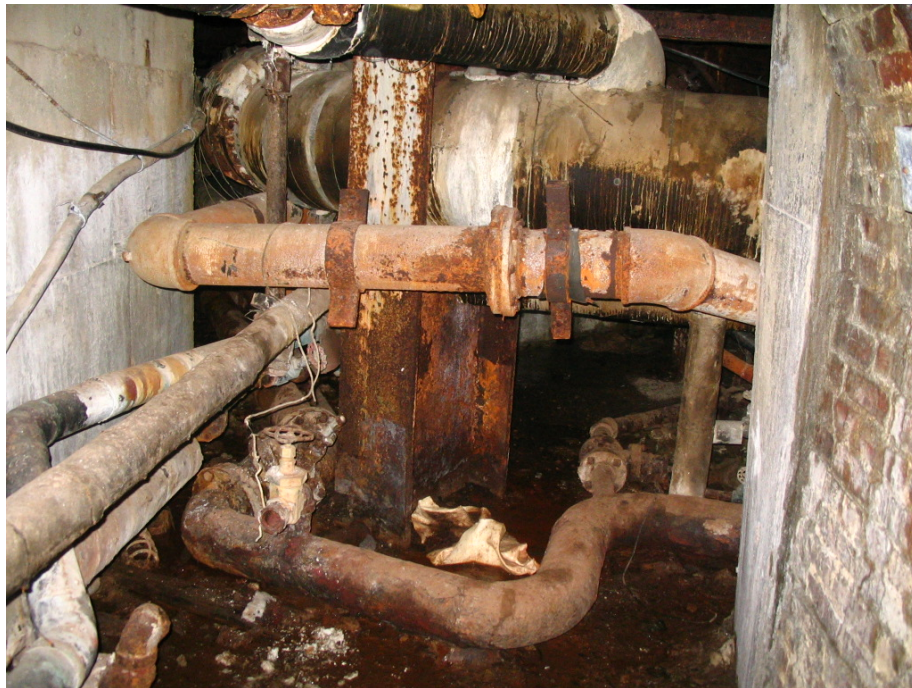
Photo 22: Corrosion on steam pipes at south end

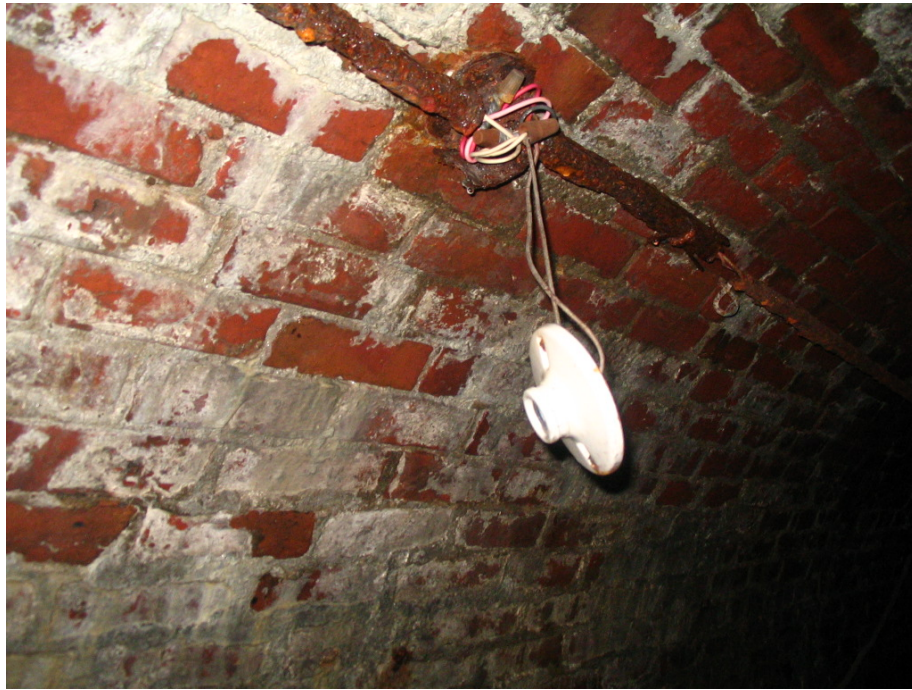
| 402.3 | Electric lines are sagging and down in many areas along the west wall. The lighting conduit along the ceiling has heavy corrosion throughout with exposed wiring. |

Photo 23: Heavy corrosion on lighting conduit; Note exposed wiring at light fixture

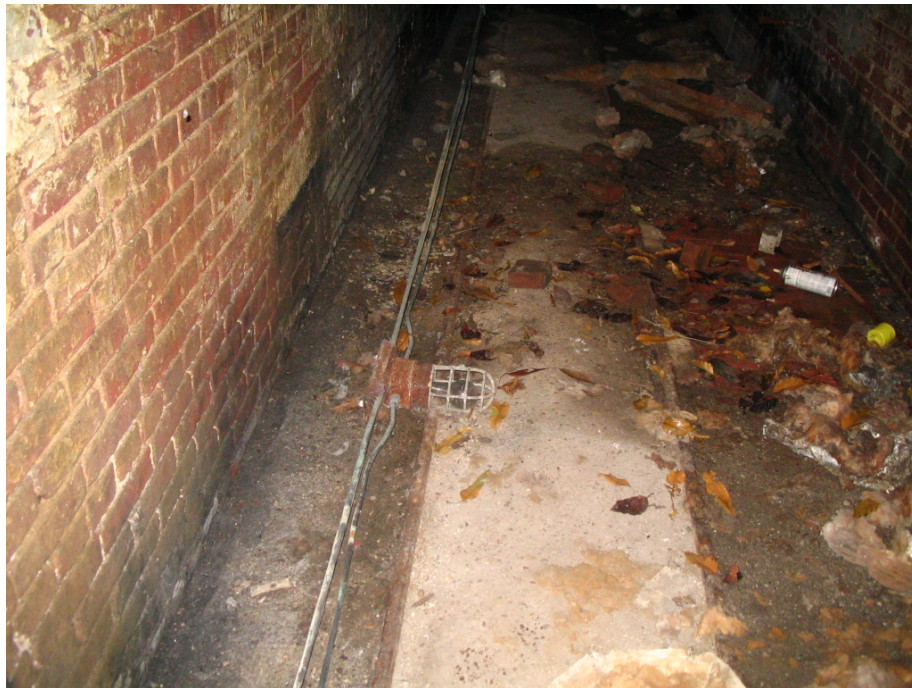
Photo 24: General view of downed lighting

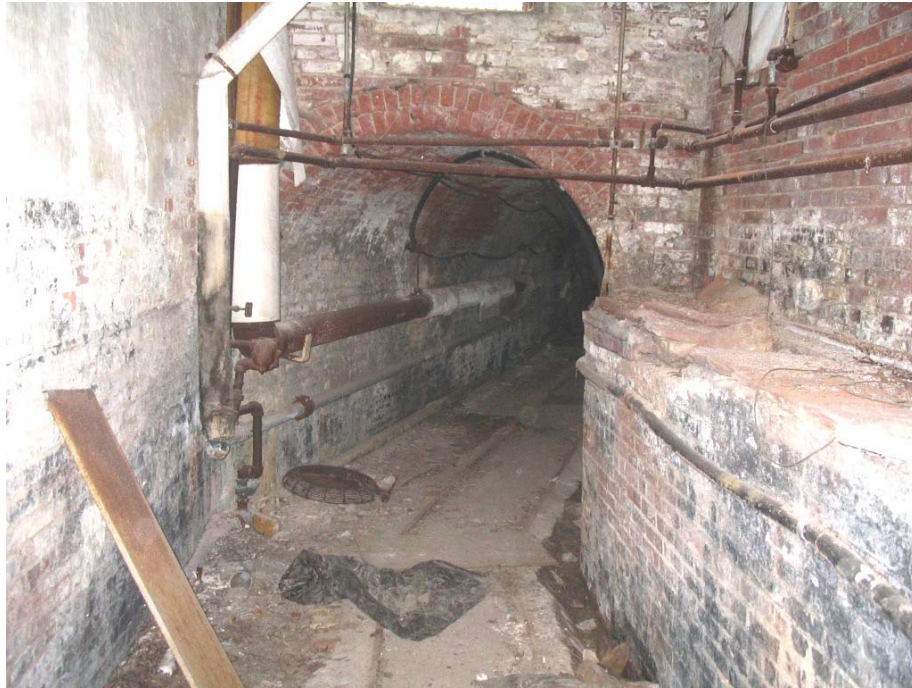
Photo 1: East portal at basement of Building 31, Atkins Hall

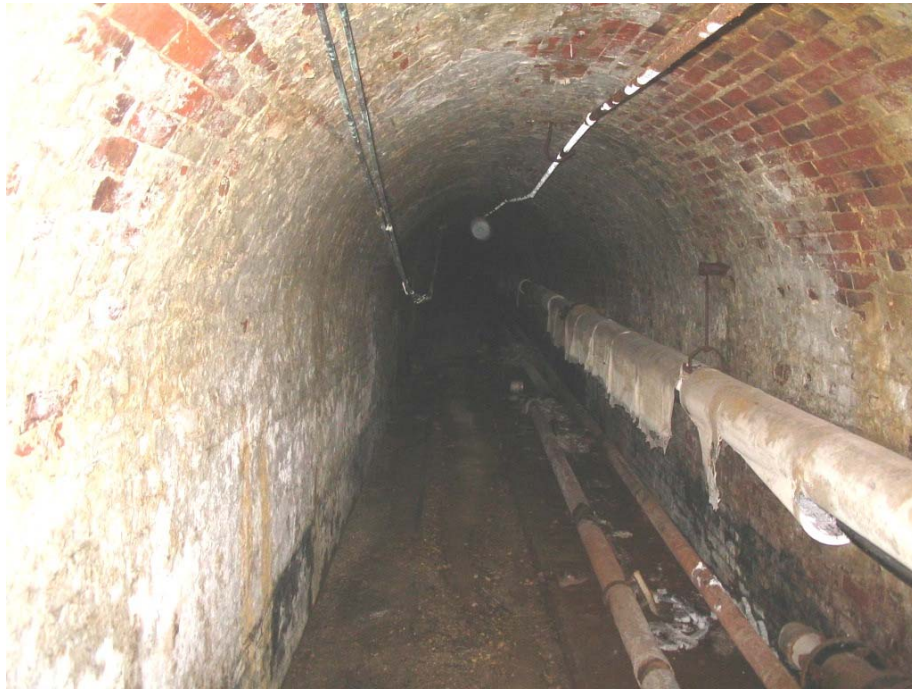
Photo 3: General view looking east from elbow below Building 44;
Note debris on floor and corrosion on pipes

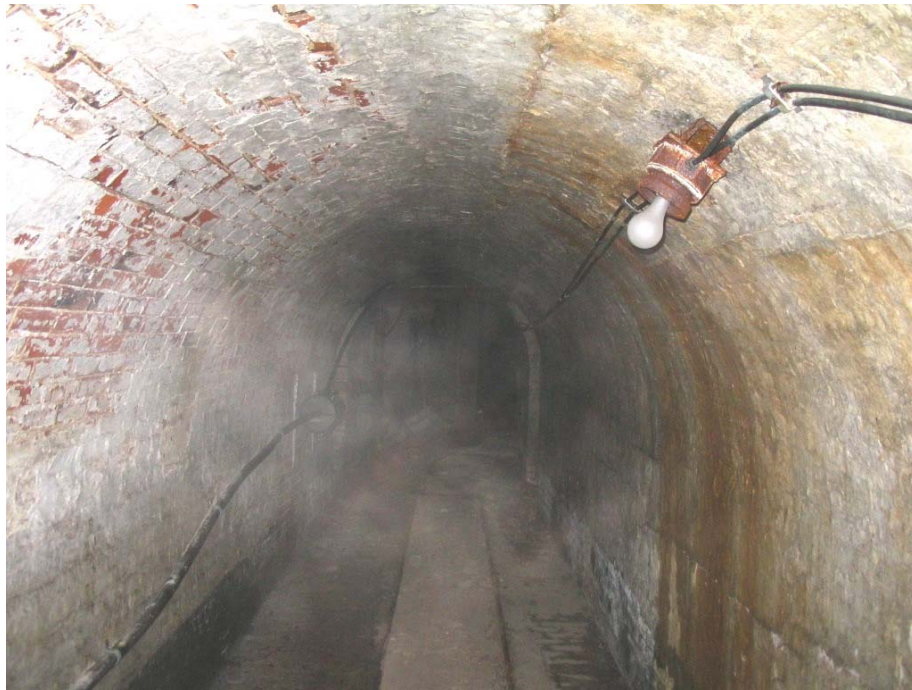
| 402.3,6 | Electrical lines for lighting and telephone cables are sagging. Lighting conduit has moderate corrosion. |

Photo 4: General view near west end; Note sagging cables

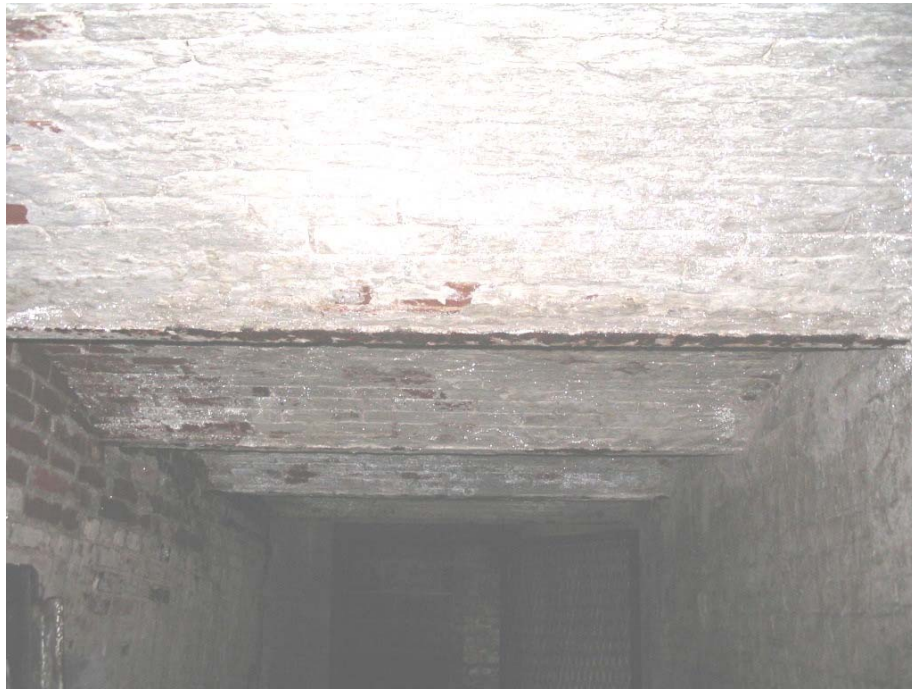
Photo 5: General view of arched ceiling near west end of tunnel

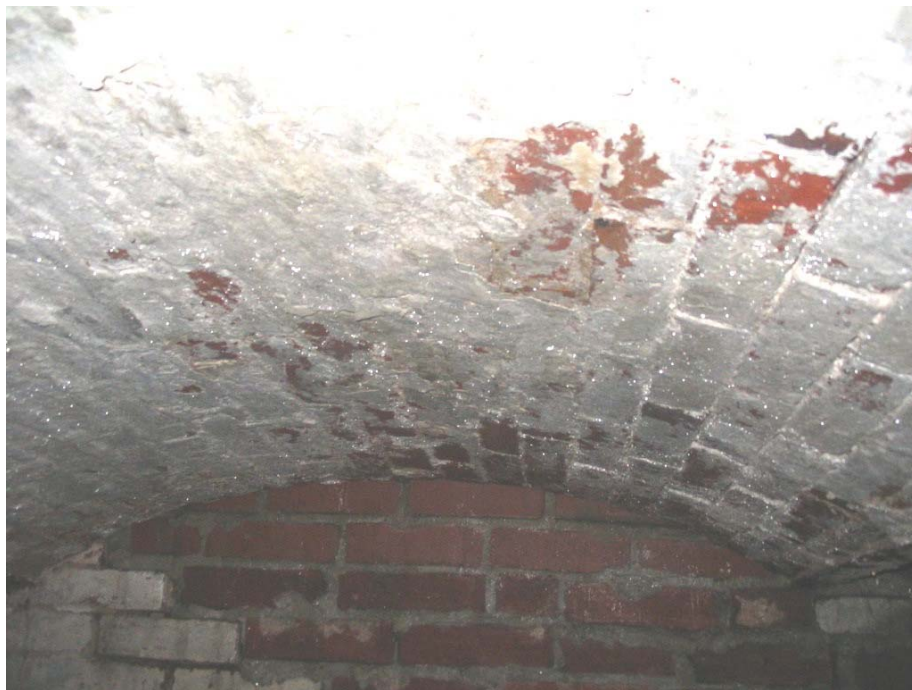
Photo 6: Detail view of arched ceiling near west end of tunnel

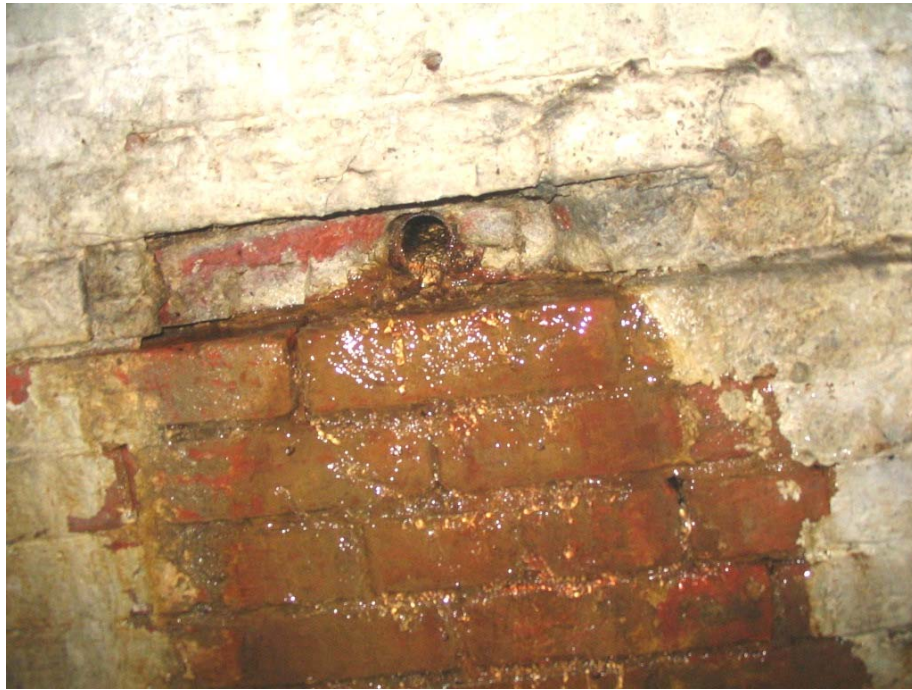
Photo 7: Water entering north wall through galvanized pipe,
west of tunnel 31-38 north portal

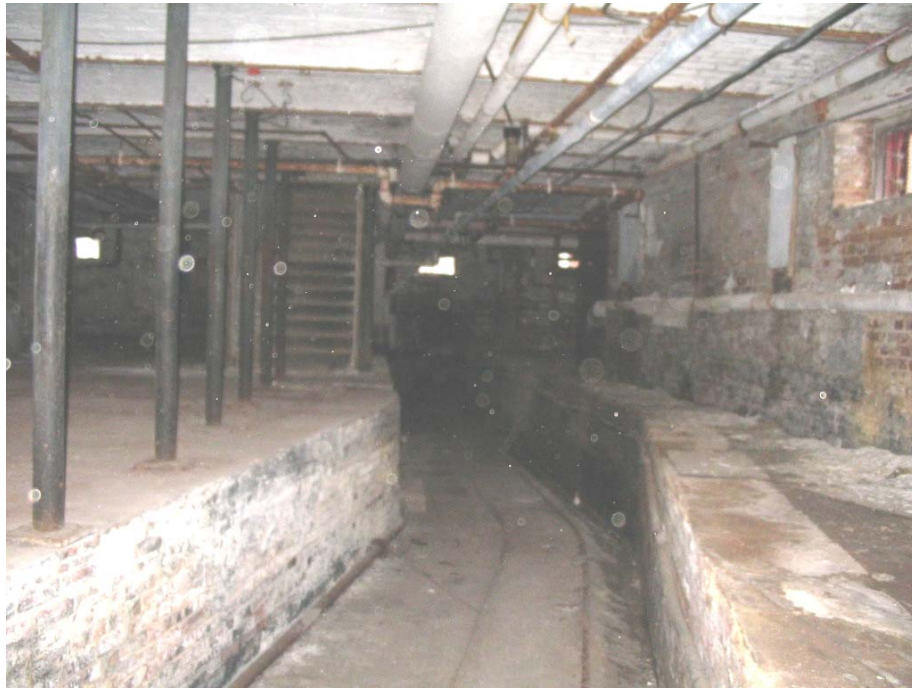
Photo 9: General view looking west toward east portal in basement of Building 31, Atkins Hall

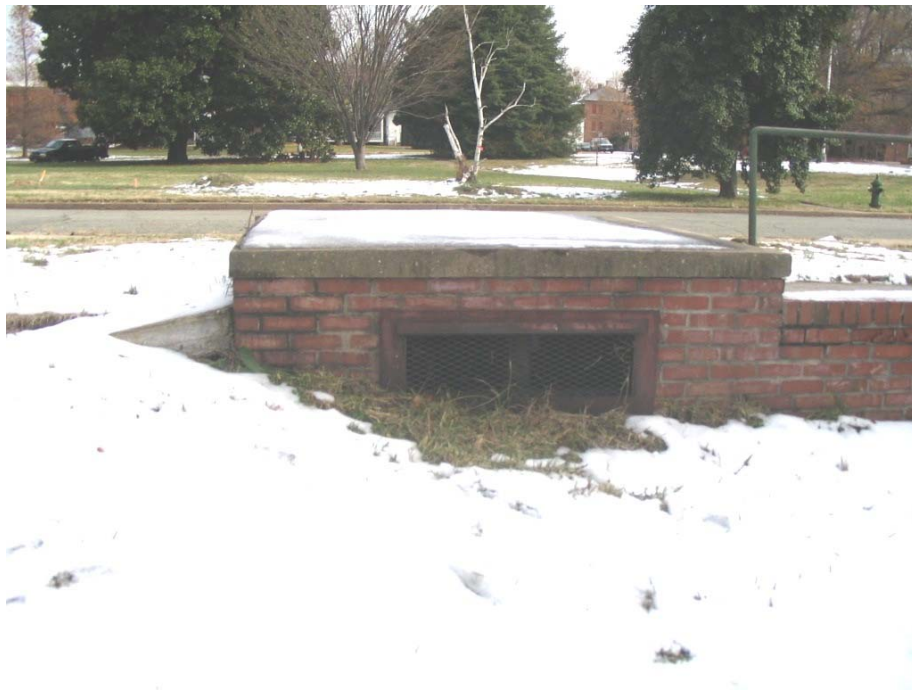
Photo 10: Blocked stairwell to west end of tunnel
